THERMOGRAPHIC INSPECTION REPORT

Demo Solar Site

2.1 Plant and Company Information

Within the scope of the thermal inspection, the important results and recommendations deemed important by us for the Demo Santral2 4.493 mw GES Project are shared below.

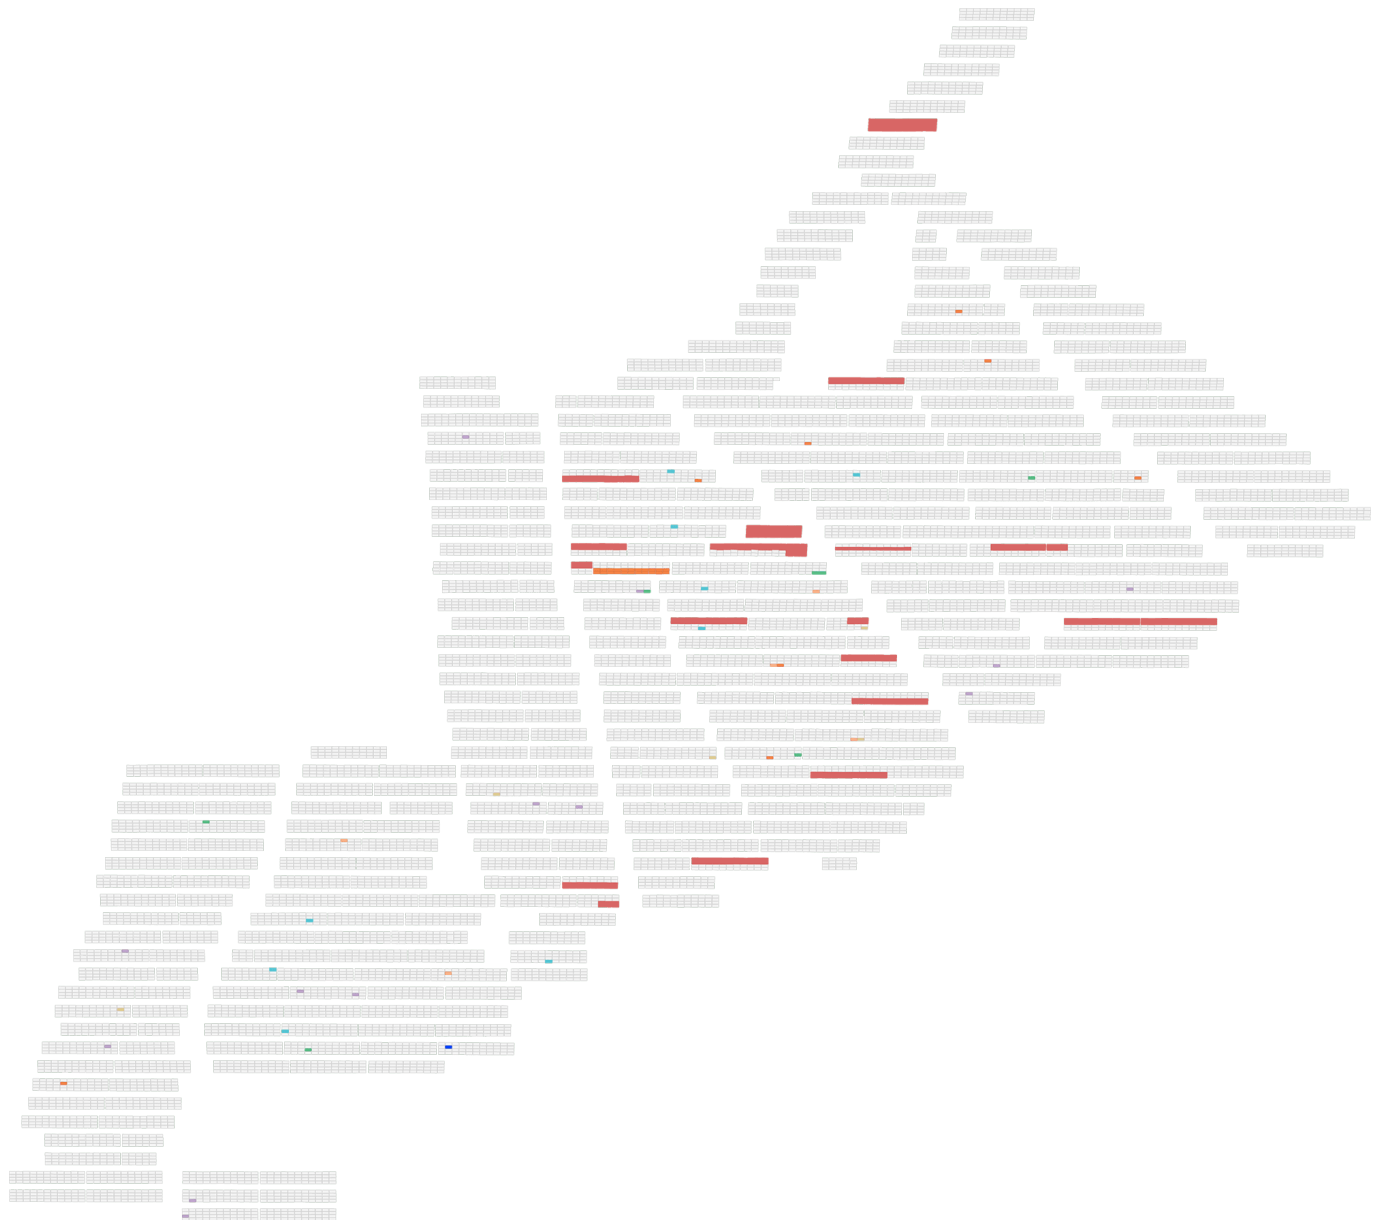
4.2 Visualization of Faulty PV Modules on the GYP

After inspecting the solar panel field, faults were detected in 457 panels. The number of faulty panels covers %2.80's of the entire field.

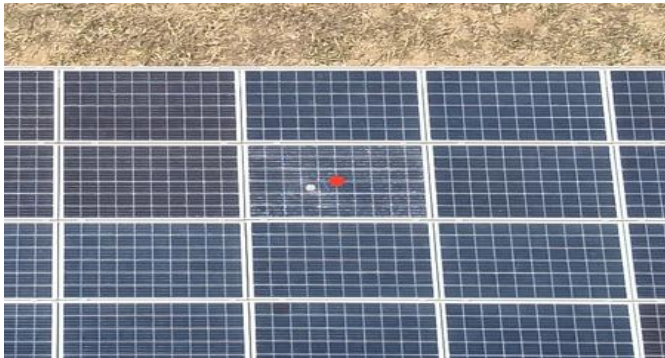
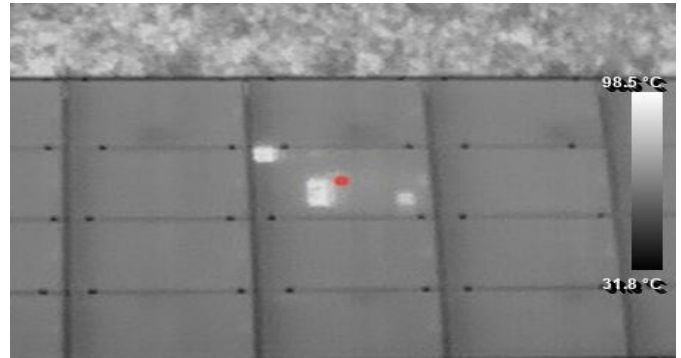
Anomaly Type Crack / Fracture	Panel Brand / Model Energy System / Es230	Field Installation Type Fixed Mounting
Anomaly Cause Unknown	Panel Serial No Unknown	Panel Tilt Angle -
Anomaly Priority High	String (Series) Number 303

Cracks or fractures occurring in solar panels cause the panels to heat up and reduce their overall performance. Additionally, cracks allow moisture and other external factors to penetrate inside the panel, damaging internal components and causing corrosion.

When a crack is detected, it is important to intervene considering the size and location of the damage. If the crack is small, replacing the cracked top layer can extend the panel's lifespan and minimize performance loss. However, if the cracks have spread over a large area, it is recommended to replace the entire module.

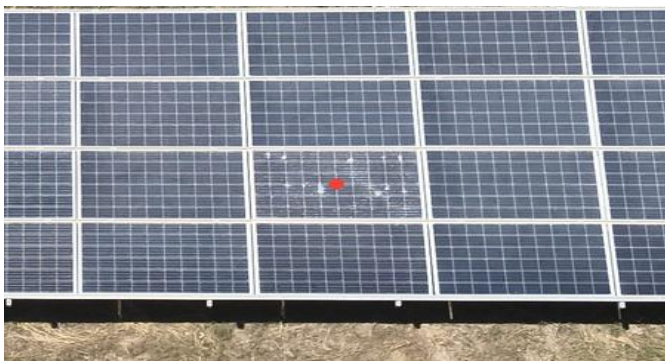
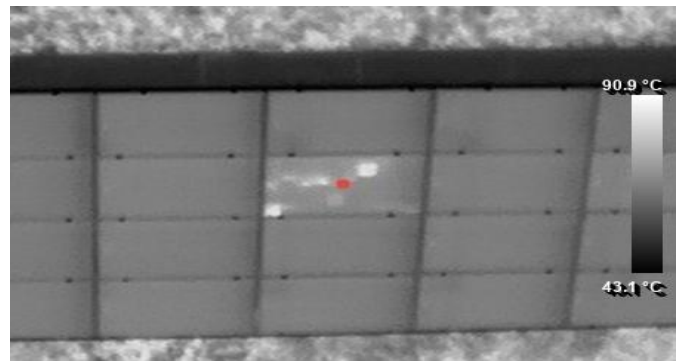
Anomaly Type Crack / Fracture	Panel Brand / Model Energy System / Es230	Field Installation Type Fixed Mounting
Anomaly Cause Unknown	Panel Serial No ZSM10201603000676	Panel Tilt Angle -
Anomaly Priority High	String (Series) Number 96

Cracks or fractures occurring in solar panels cause the panels to heat up and reduce their overall performance. Additionally, cracks allow moisture and other external factors to penetrate inside the panel, damaging internal components and causing corrosion.

When a crack is detected, it is important to intervene considering the size and location of the damage. If the crack is small, replacing the cracked top layer can extend the panel's lifespan and minimize performance loss. However, if the cracks have spread over a large area, it is recommended to replace the entire module.

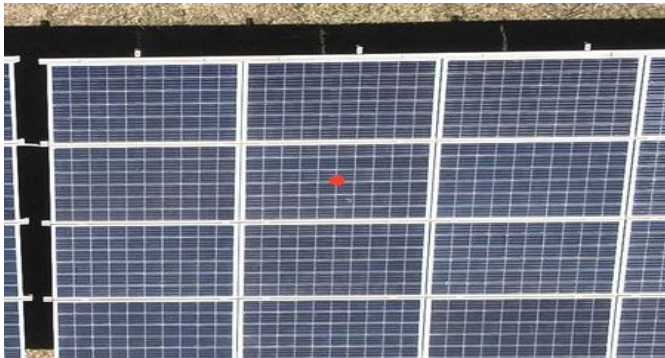
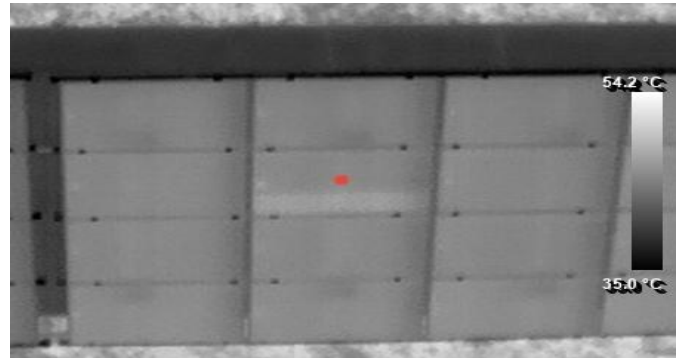
Anomaly Type Diode	Panel Brand / Model Energy System / Es230	Field Installation Type Fixed Mounting
Anomaly Cause Unknown	Panel Serial No Unknown	Panel Tilt Angle -
Anomaly Priority High	String (Series) Number 327

A fault in a bypass diode of the solar panel creates heating problems in one-third of the module. Diodes are critical components that protect the panel during overcurrent or overvoltage conditions. A faulty diode should be replaced quickly before it can cause damage to other parts of the panel.

The faulty diode must be replaced immediately. Using an incorrect or low-quality diode can lead to more significant damages to the panel, so high-quality diodes with appropriate specifications should be used during replacement.

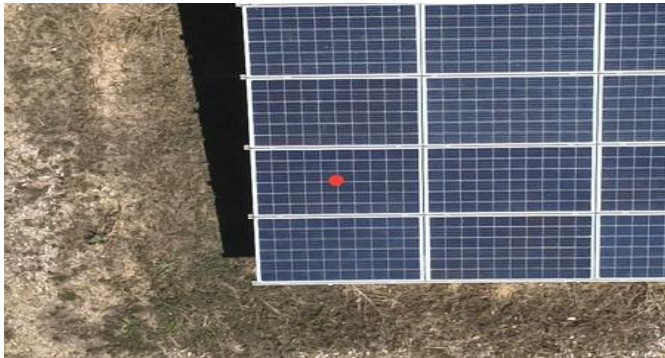
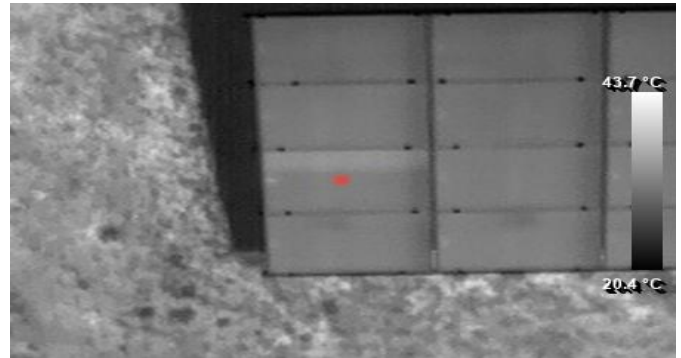
Anomaly Type Diode	Panel Brand / Model Energy System / Es230	Field Installation Type Fixed Mounting
Anomaly Cause Unknown	Panel Serial No Unknown	Panel Tilt Angle -
Anomaly Priority Medium	String (Series) Number 370

A fault in a bypass diode of the solar panel creates heating problems in one-third of the module. Diodes are critical components that protect the panel during overcurrent or overvoltage conditions. A faulty diode should be replaced quickly before it can cause damage to other parts of the panel.

The faulty diode must be replaced immediately. Using an incorrect or low-quality diode can lead to more significant damages to the panel, so high-quality diodes with appropriate specifications should be used during replacement.

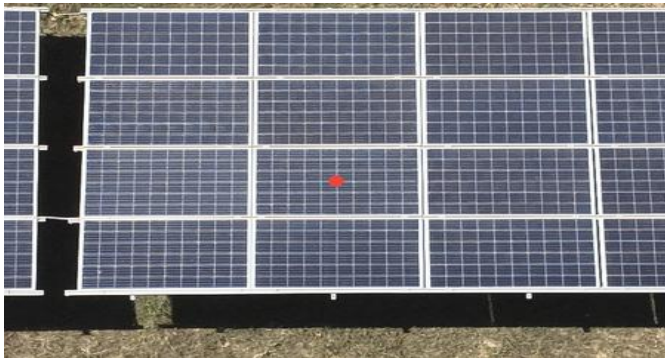
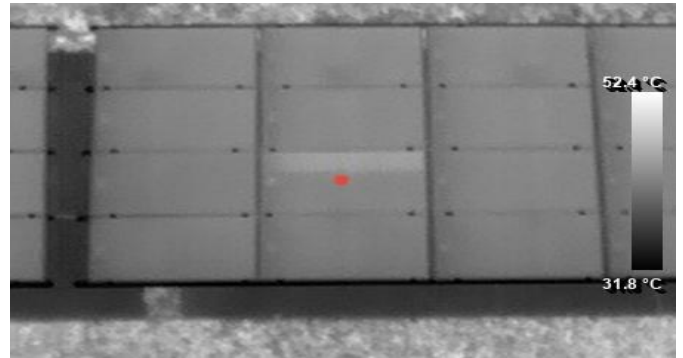
Anomaly Type Diode	Panel Brand / Model Energy System / Es230	Field Installation Type Fixed Mounting
Anomaly Cause Unknown	Panel Serial No Unknown	Panel Tilt Angle -
Anomaly Priority High	String (Series) Number 341

A fault in a bypass diode of the solar panel creates heating problems in one-third of the module. Diodes are critical components that protect the panel during overcurrent or overvoltage conditions. A faulty diode should be replaced quickly before it can cause damage to other parts of the panel.

The faulty diode must be replaced immediately. Using an incorrect or low-quality diode can lead to more significant damages to the panel, so high-quality diodes with appropriate specifications should be used during replacement.

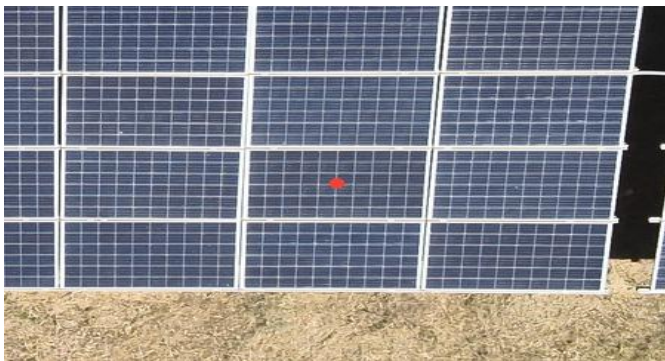
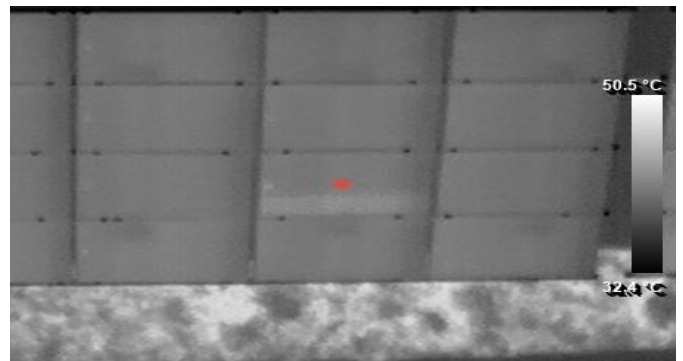
Anomaly Type Diode	Panel Brand / Model Energy System / Es230	Field Installation Type Fixed Mounting
Anomaly Cause Unknown	Panel Serial No Unknown	Panel Tilt Angle -
Anomaly Priority Medium	String (Series) Number 327

A fault in a bypass diode of the solar panel creates heating problems in one-third of the module. Diodes are critical components that protect the panel during overcurrent or overvoltage conditions. A faulty diode should be replaced quickly before it can cause damage to other parts of the panel.

The faulty diode must be replaced immediately. Using an incorrect or low-quality diode can lead to more significant damages to the panel, so high-quality diodes with appropriate specifications should be used during replacement.

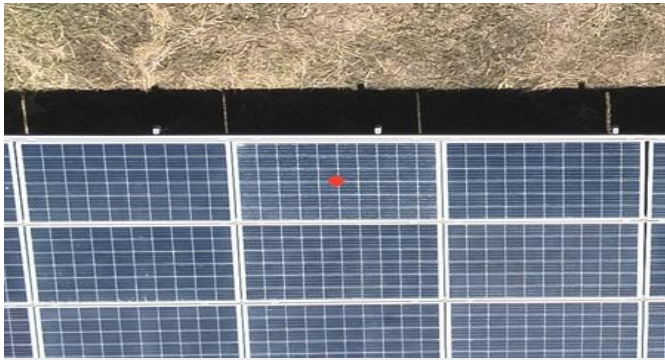
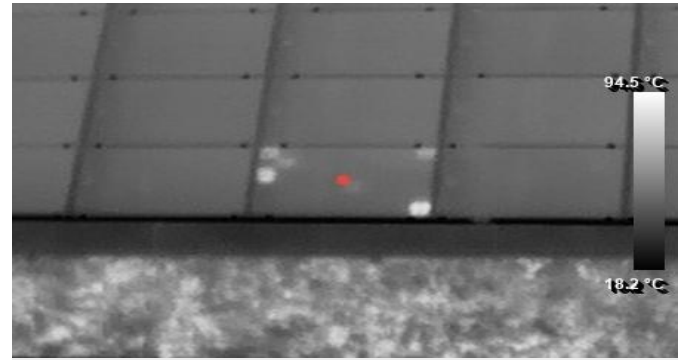
Anomaly Type Multi-Cell	Panel Brand / Model Energy System / Es230	Field Installation Type Fixed Mounting
Anomaly Cause Unknown	Panel Serial No ZSM10201603000676	Panel Tilt Angle -
Anomaly Priority High	String (Series) Number 42

Heating affecting multiple cells in the solar panel and occurring with a quadrangular geometry can affect a large portion of the panel, reducing energy production. Such damages can endanger the overall health of the panel.

Multi-cell damage usually requires the replacement of the panel. However, after a detailed technical examination, repair may be possible depending on the extent of the damage. This will allow the panel to have a longer lifespan and maintain overall energy efficiency.

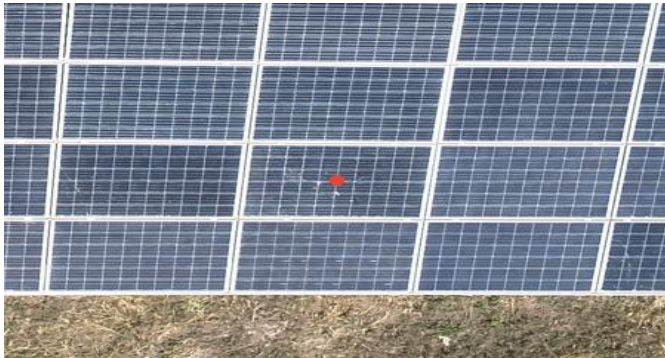
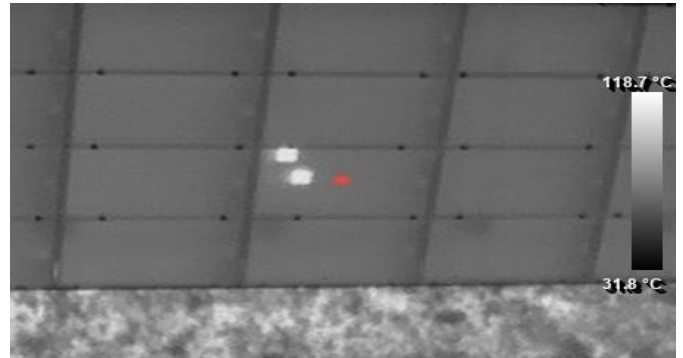
Anomaly Type Multi-Cell	Panel Brand / Model Energy System / Es230	Field Installation Type Fixed Mounting
Anomaly Cause Unknown	Panel Serial No Unknown	Panel Tilt Angle -
Anomaly Priority High	String (Series) Number 28

Heating affecting multiple cells in the solar panel and occurring with a quadrangular geometry can affect a large portion of the panel, reducing energy production. Such damages can endanger the overall health of the panel.

Multi-cell damage usually requires the replacement of the panel. However, after a detailed technical examination, repair may be possible depending on the extent of the damage. This will allow the panel to have a longer lifespan and maintain overall energy efficiency.

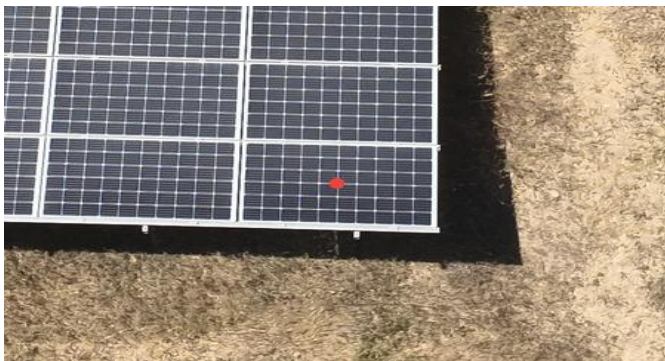
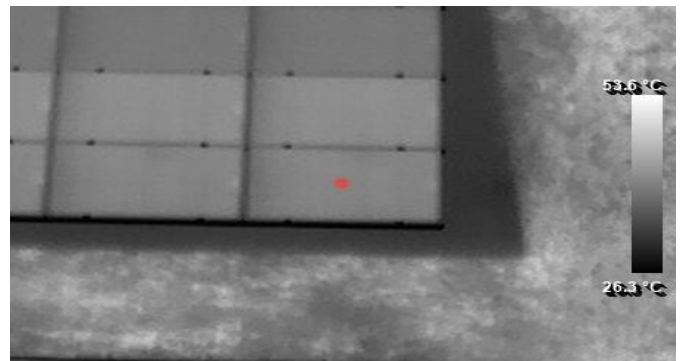
Anomaly Type String (Panel Count)	Panel Brand / Model Energy System / Es230	Field Installation Type Fixed Mounting
Anomaly Cause Unknown	Panel Serial No Unknown	Panel Tilt Angle -
Anomaly Priority Medium	String (Series) Number 139

A condition where multiple modules in a string of solar panels connected in series are damaged can seriously affect the overall system performance. Such issues may arise from connection errors between modules, faulty wiring, or physical damages caused by external factors.

When string faults are detected, the first step is to ensure that all connector connections between the modules are correct and secure. Loose or damaged connections can lead to faults. Next, the electrical connections should be thoroughly examined using technical equipment.

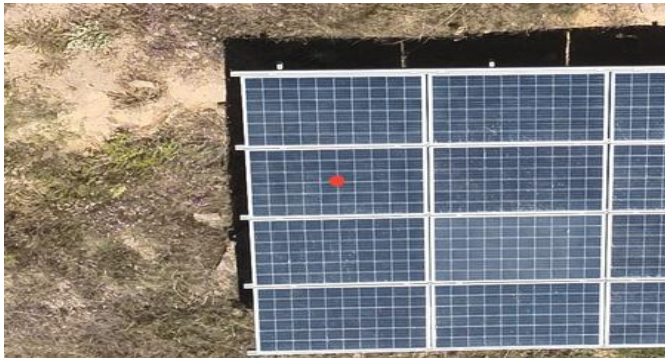
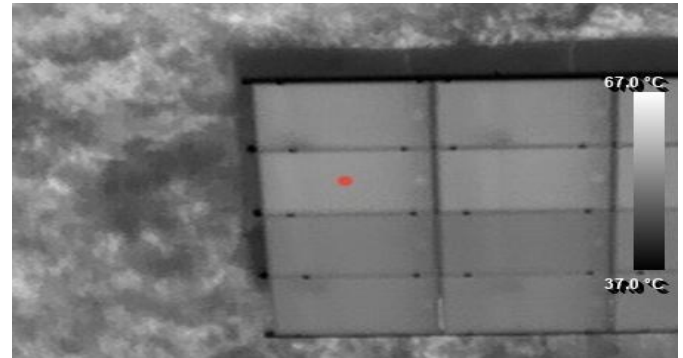
Anomaly Type String (Panel Count)	Panel Brand / Model Energy System / Es230	Field Installation Type Fixed Mounting
Anomaly Cause Unknown	Panel Serial No Unknown	Panel Tilt Angle -
Anomaly Priority Medium	String (Series) Number 49

A condition where multiple modules in a string of solar panels connected in series are damaged can seriously affect the overall system performance. Such issues may arise from connection errors between modules, faulty wiring, or physical damages caused by external factors.

When string faults are detected, the first step is to ensure that all connector connections between the modules are correct and secure. Loose or damaged connections can lead to faults. Next, the electrical connections should be thoroughly examined using technical equipment.

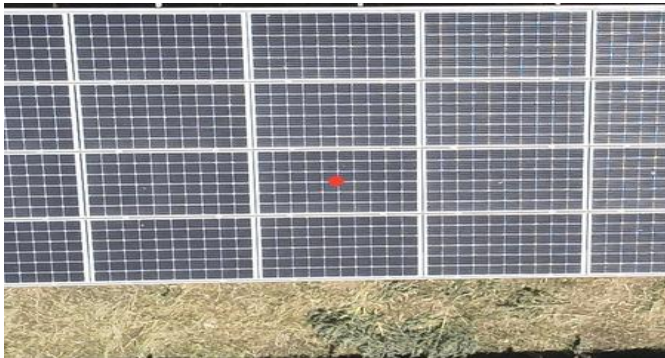
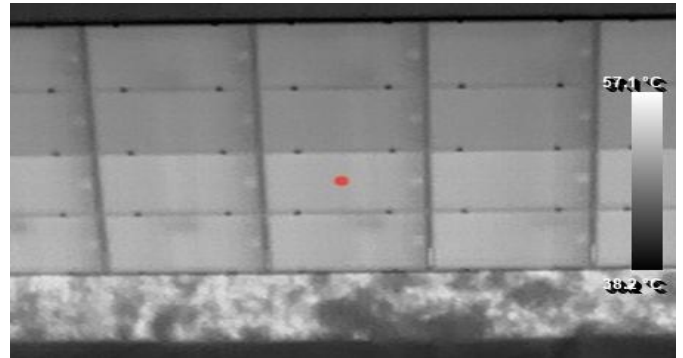
Anomaly Type String (Panel Count)	Panel Brand / Model Energy System / Es230	Field Installation Type Fixed Mounting
Anomaly Cause Unknown	Panel Serial No Unknown	Panel Tilt Angle -
Anomaly Priority Medium	String (Series) Number 245

A condition where multiple modules in a string of solar panels connected in series are damaged can seriously affect the overall system performance. Such issues may arise from connection errors between modules, faulty wiring, or physical damages caused by external factors.

When string faults are detected, the first step is to ensure that all connector connections between the modules are correct and secure. Loose or damaged connections can lead to faults. Next, the electrical connections should be thoroughly examined using technical equipment.

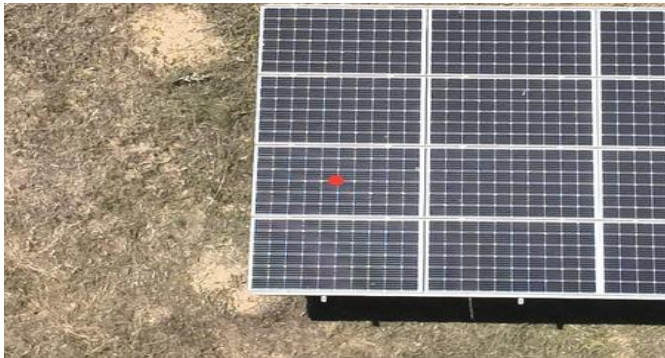
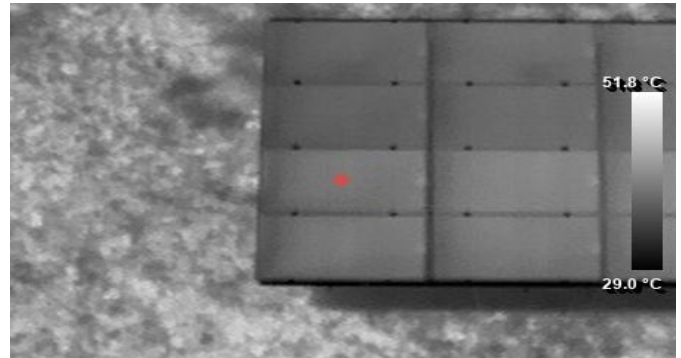
Anomaly Type String (Panel Count)	Panel Brand / Model Energy System / Es230	Field Installation Type Fixed Mounting
Anomaly Cause Unknown	Panel Serial No Unknown	Panel Tilt Angle -
Anomaly Priority Medium	String (Series) Number 287

A condition where multiple modules in a string of solar panels connected in series are damaged can seriously affect the overall system performance. Such issues may arise from connection errors between modules, faulty wiring, or physical damages caused by external factors.

When string faults are detected, the first step is to ensure that all connector connections between the modules are correct and secure. Loose or damaged connections can lead to faults. Next, the electrical connections should be thoroughly examined using technical equipment.

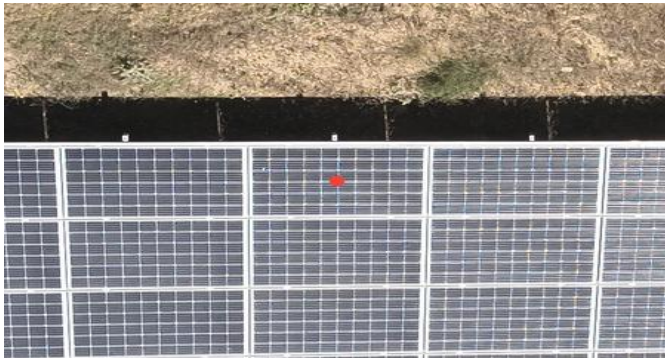
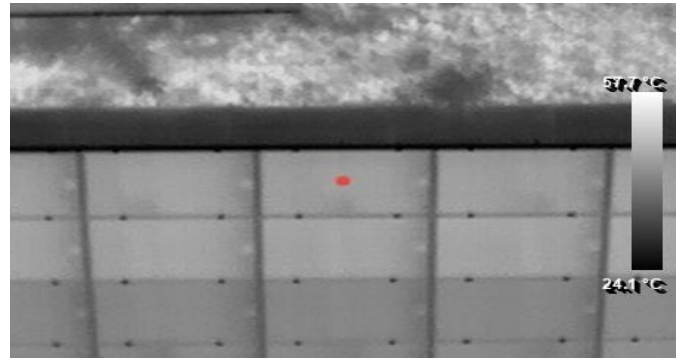
Anomaly Type String (Panel Count)	Panel Brand / Model Energy System / Es230	Field Installation Type Fixed Mounting
Anomaly Cause Unknown	Panel Serial No Unknown	Panel Tilt Angle -
Anomaly Priority Medium	String (Series) Number 141

A condition where multiple modules in a string of solar panels connected in series are damaged can seriously affect the overall system performance. Such issues may arise from connection errors between modules, faulty wiring, or physical damages caused by external factors.

When string faults are detected, the first step is to ensure that all connector connections between the modules are correct and secure. Loose or damaged connections can lead to faults. Next, the electrical connections should be thoroughly examined using technical equipment.

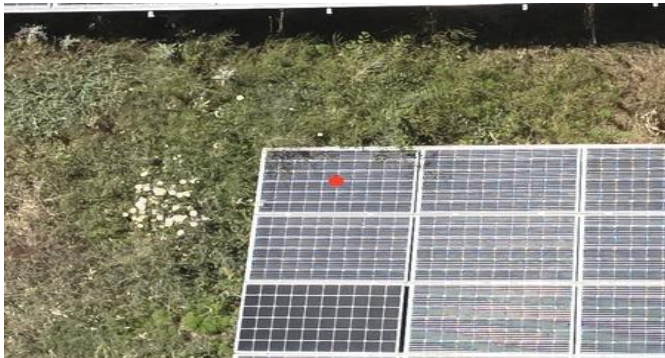
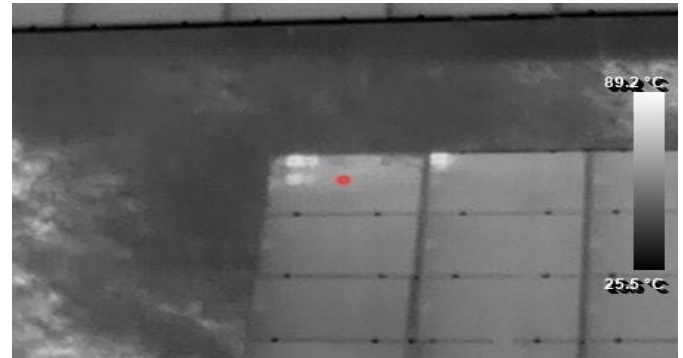
Anomaly Type Vegetation Shadowing	Panel Brand / Model Energy System / Es230	Field Installation Type Fixed Mounting
Anomaly Cause Unknown	Panel Serial No Unknown	Panel Tilt Angle -
Anomaly Priority High	String (Series) Number 152

Uncontrolled vegetation growth around solar panels can cast shadows on the panels, causing them to heat up and reducing panel performance. Furthermore, vegetation can lead to moisture accumulation, damaging the panel structure.

Plants causing shading on the modules should be removed. Additionally, regular landscape maintenance and controlling vegetation will minimize shading and moisture problems, ensuring the panels work efficiently and extending their lifespan.

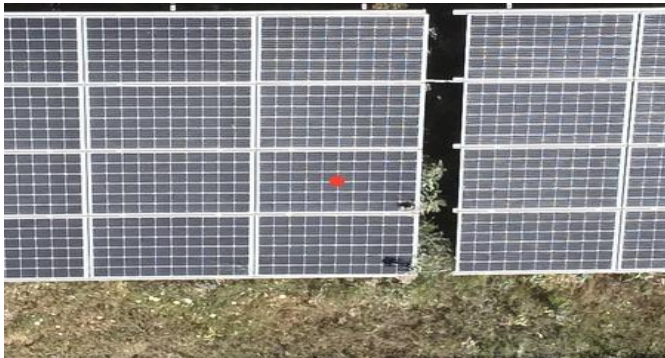
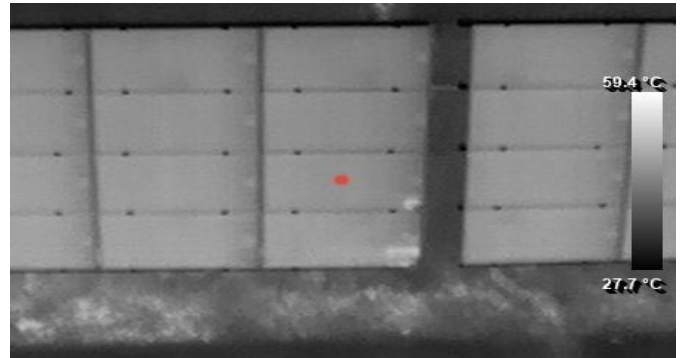
Anomaly Type Vegetation Shadowing	Panel Brand / Model Energy System / Es230	Field Installation Type Fixed Mounting
Anomaly Cause Unknown	Panel Serial No Unknown	Panel Tilt Angle -
Anomaly Priority High	String (Series) Number 227

Uncontrolled vegetation growth around solar panels can cast shadows on the panels, causing them to heat up and reducing panel performance. Furthermore, vegetation can lead to moisture accumulation, damaging the panel structure.

Plants causing shading on the modules should be removed. Additionally, regular landscape maintenance and controlling vegetation will minimize shading and moisture problems, ensuring the panels work efficiently and extending their lifespan.

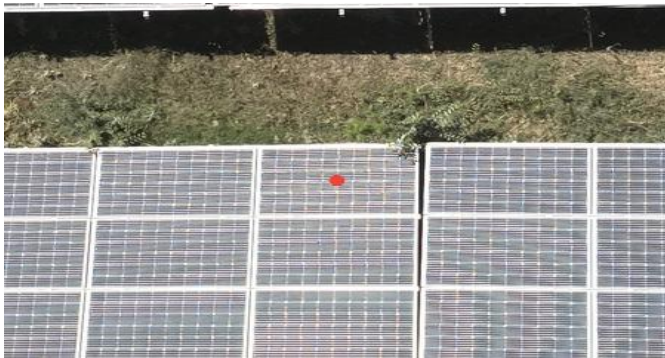
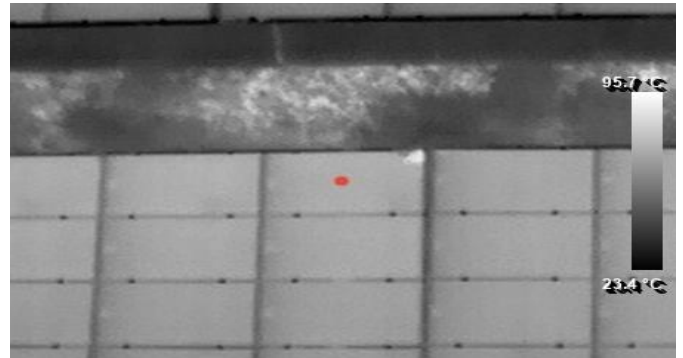
Anomaly Type Vegetation Shadowing	Panel Brand / Model Energy System / Es230	Field Installation Type Fixed Mounting
Anomaly Cause Unknown	Panel Serial No Unknown	Panel Tilt Angle -
Anomaly Priority High	String (Series) Number 159

Uncontrolled vegetation growth around solar panels can cast shadows on the panels, causing them to heat up and reducing panel performance. Furthermore, vegetation can lead to moisture accumulation, damaging the panel structure.

Plants causing shading on the modules should be removed. Additionally, regular landscape maintenance and controlling vegetation will minimize shading and moisture problems, ensuring the panels work efficiently and extending their lifespan.
