4.0 Thermographic Inspection Results

Demo Santral2

Demo Şirket

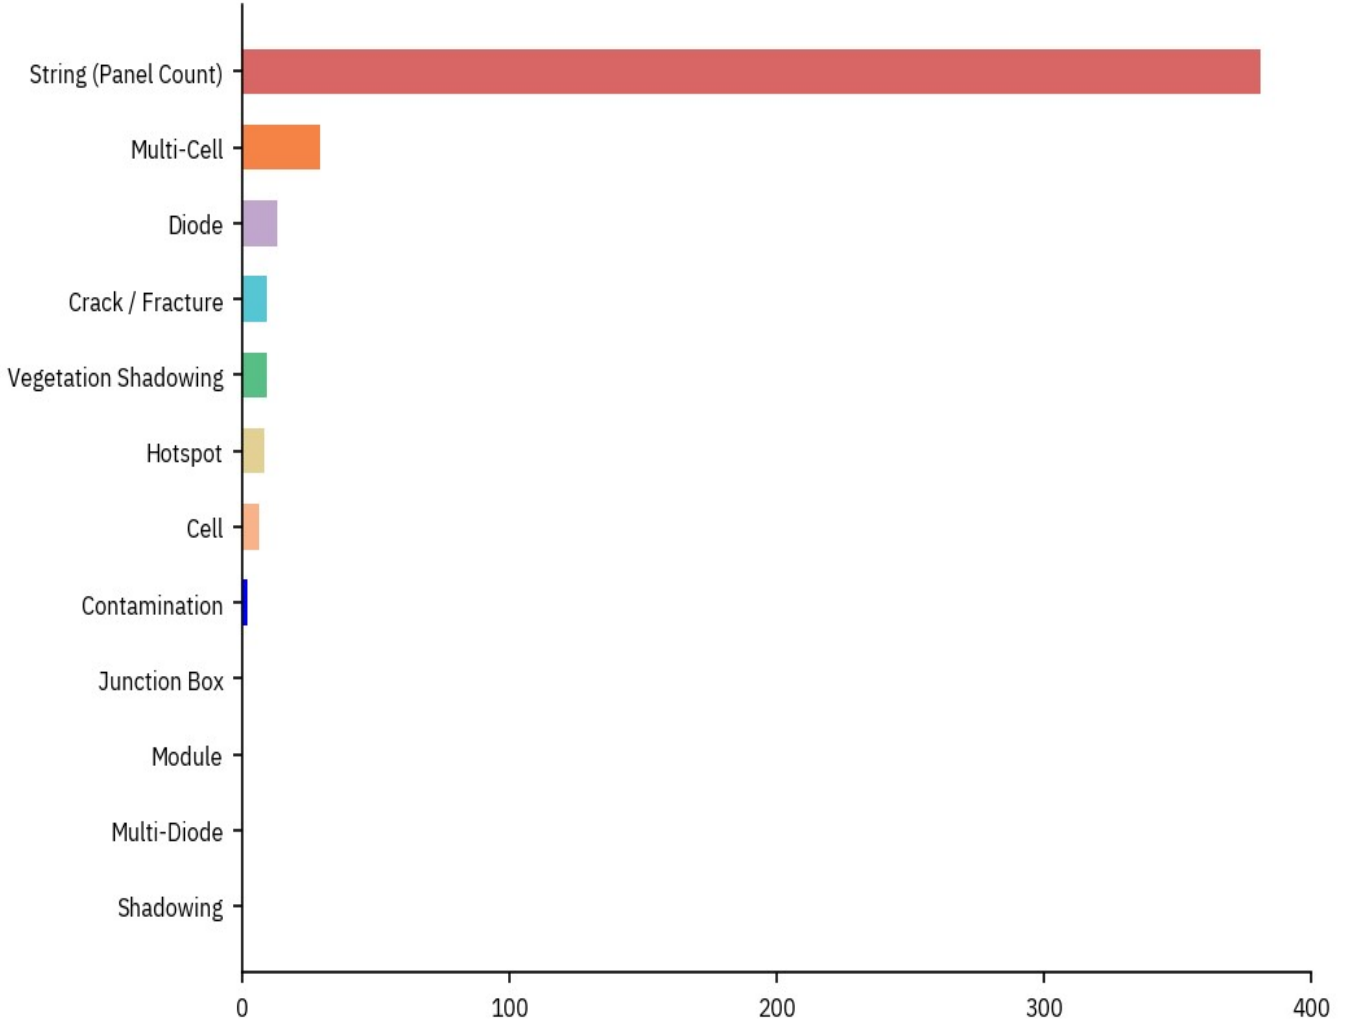
After inspecting the solar panel field, faults were detected in 457 panels. The number of faulty panels covers %2.80's of the entire field.

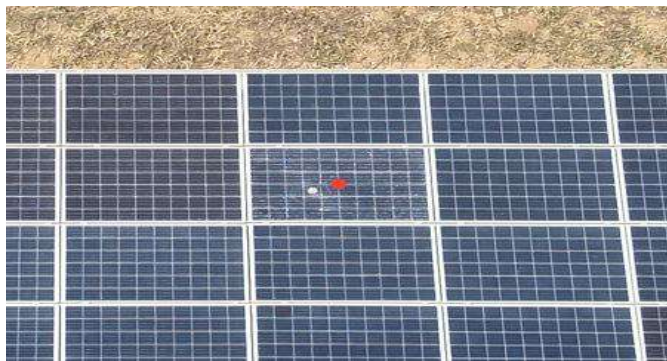
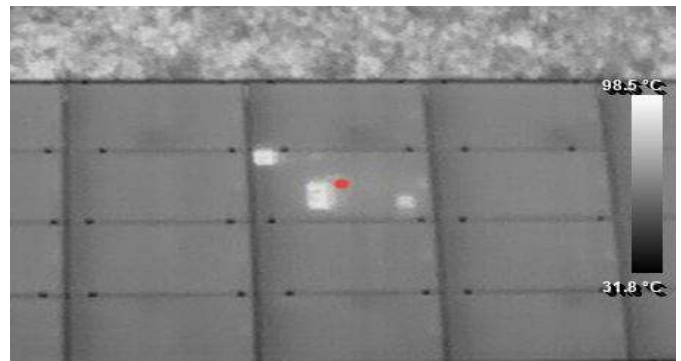
Anomaly Type Crack / Fracture	Panel Brand / Model Energy System / Es230	Field Installation Type Fixed Mounting
Anomaly Cause Unknown	Panel Serial No Unknown	Panel Tilt Angle -
Anomaly Priority High	String (Series) Number 303

Minimum : 40.1°C
Maksimum : 98.5°C
OAverage : 52.35°C
Delta T (Δ T) : 58.4C
Emissivity : 0.85

Cracks or fractures occurring in solar panels cause the panels to heat up and reduce their overall performance. Additionally, cracks allow moisture and other external factors to penetrate inside the panel, damaging internal components and causing corrosion.

When a crack is detected, it is important to intervene considering the size and location of the damage. If the crack is small, replacing the cracked top layer can extend the panel's lifespan and minimize performance loss. However, if the cracks have spread over a large area, it is recommended to replace the entire module.

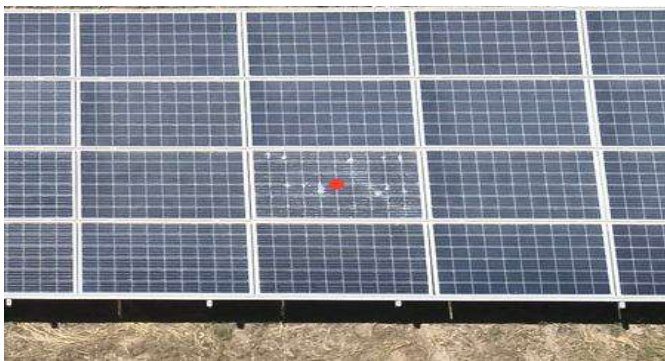
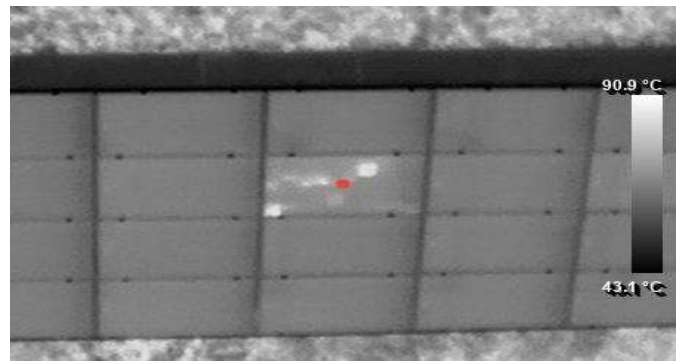
Anomaly Type Crack / Fracture	Panel Brand / Model Energy System / Es230	Field Installation Type Fixed Mounting
Anomaly Cause Unknown	Panel Serial No ZSM10201603000676	Panel Tilt Angle -
Anomaly Priority High	String (Series) Number 96

Minimum : 40.1°C
Maksimum : 89.2°C
OAverage : 53.65°C
Delta T (Δ T) : 49.1C
Emissivity : 0.85

Cracks or fractures occurring in solar panels cause the panels to heat up and reduce their overall performance. Additionally, cracks allow moisture and other external factors to penetrate inside the panel, damaging internal components and causing corrosion.

When a crack is detected, it is important to intervene considering the size and location of the damage. If the crack is small, replacing the cracked top layer can extend the panel's lifespan and minimize performance loss. However, if the cracks have spread over a large area, it is recommended to replace the entire module.
